Service Bulletin 2023-001

Subject: Zig zag stitching on main container flap #2

Status: advisory

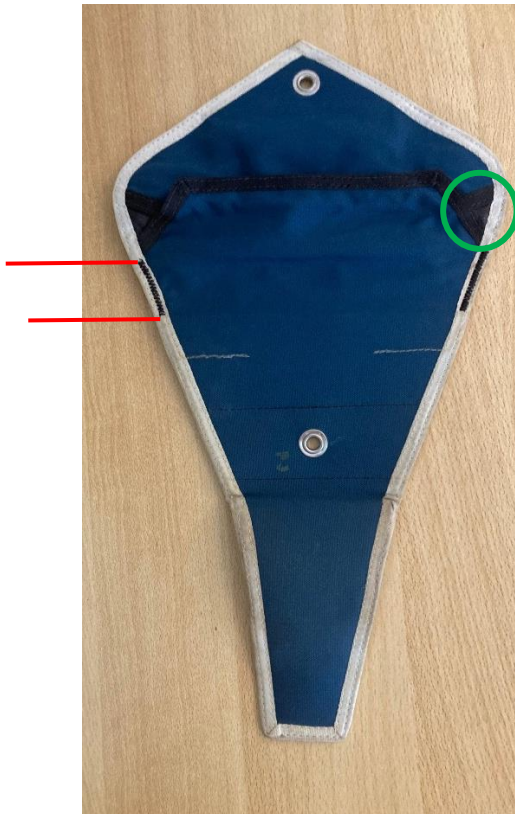
We have been informed that during the activation of the main canopy, one suspension line of the left rear suspension lines caught on the main container flap #2.

As a result, the main canopy didn't separate fully after the emergency procedure and the skydiver had a hard landing and was taken to hospital for check-up.

During the pack job the lines had to be laid under the reserve container as described on page 50 in our OWNER MANUAL as **WRONG** and the main canopy had to have a pulling direction which would be due to an unstable body position.

Before the next reserve repack your rigger may strengthen the main container flap #2 with a zig zag stitching as shown on the picture between the two red lines. Start at the end of the binding, where the flap is attached to the reserve container and end at the beginning of the stiffener (red lines in the picture below). Overstitch your zig zag stitching once.

Don't stitch over the two bindings (green circle in the picture below) because there are already two bar tacks under the binding. You don't have to separate the flap from the reserve container while doing the zig zag stitching.
