Service Bulletin 2023-001

Subject: Zig zag stitching on main container flap #2

Status: advisory

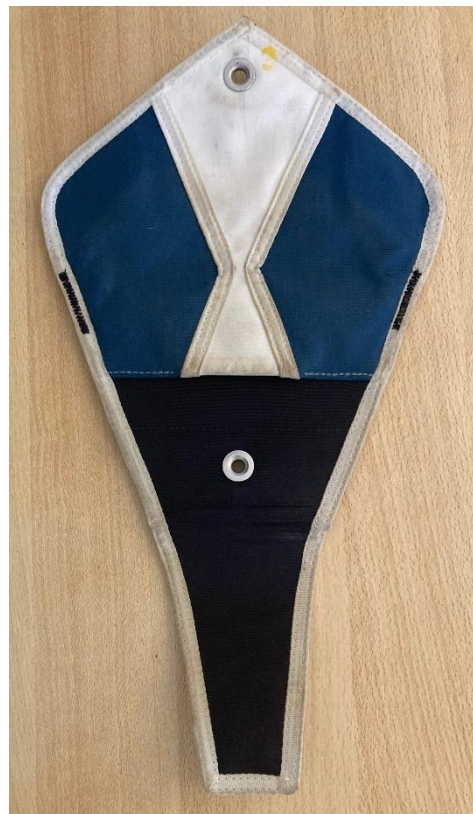
We have been informed that during the activation of the main canopy, one suspension line of the left rear suspension lines caught on the main container flap #2.

Unfortunately, we didn't have the chance to inspect the affected harness and container system to find out the concrete reason why the line was caught on the main container flap #2.

Before the next reserve repack your rigger may strengthen the main container flap #2 with a zig zag stitching as shown on the picture between the two red lines. Start at the end of the binding, where the flap is attached to the reserve container and end at the beginning of the stiffener (red lines in the picture below). Overstitch your zig zag stitching once.

Don't stitch over the two bindings (green circle in the picture below) because there are already two bar tacks under the binding. You don't have to separate the flap from the reserve container while doing the zig zag stitching.
